Detection of electrical discharges in bearings

White Paper

Author: Sylvain Humbert
Date: November 2008
SKF Maintenance Products

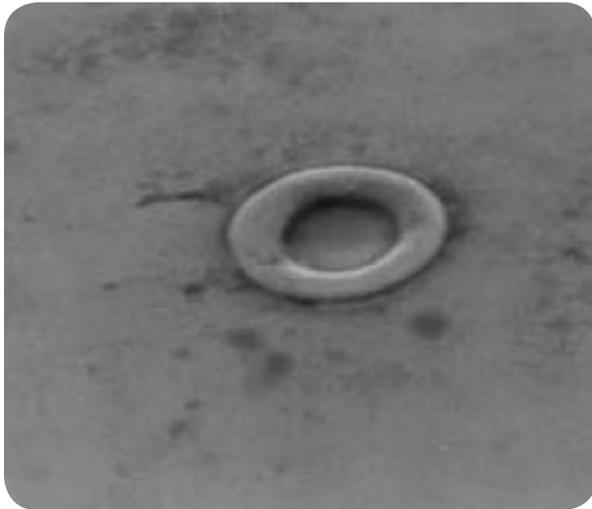
Figure 5: micro crater of a few um in diameter

The first stage of damage is not visible to the naked eye: micro craters due to the electrical discharge machining current phenomenon. As shown in *figure 5*, what happens is similar to spot welding; a local melting of the material. However, when this occurs thousands of times, micro cratering occurs. The sparks create many small craters by removing material from the rolling elements or the raceways. First it causes the rolling elements or raceway to melt. Secondly, due to the heat produced by the current discharge, the material vaporizes, and the remaining particles are washed away. See *figure 6*.

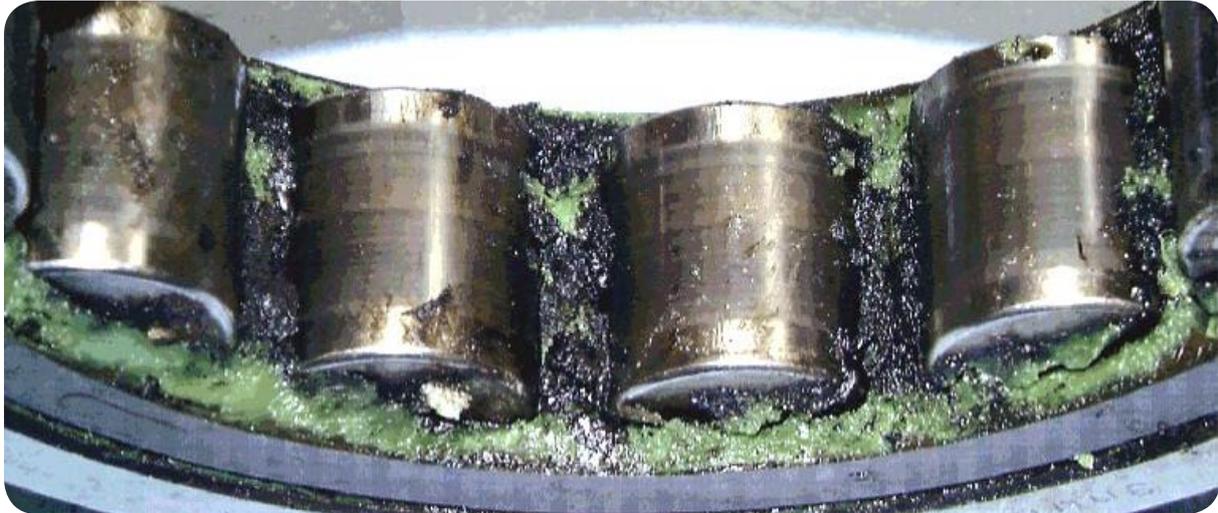
Figure 9: Blackened grease

Finally, electrical erosion can cause lubricant decomposition and degradation. Blackened grease is a common sign of advanced electrical erosion as high temperature peaks locally cause the thickener, base oil and additives to react. See *figure 9*.

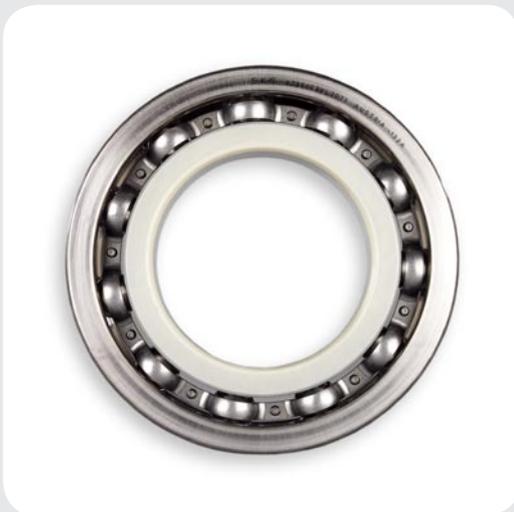
Figure 11: SKF INSOCOAT bearing

- Using insulated bearings like SKF INSOCOAT bearings, for either both bearings or just non-drive end bearing (NDE) to open the low frequency current circulating circuit. See *figure 11*.

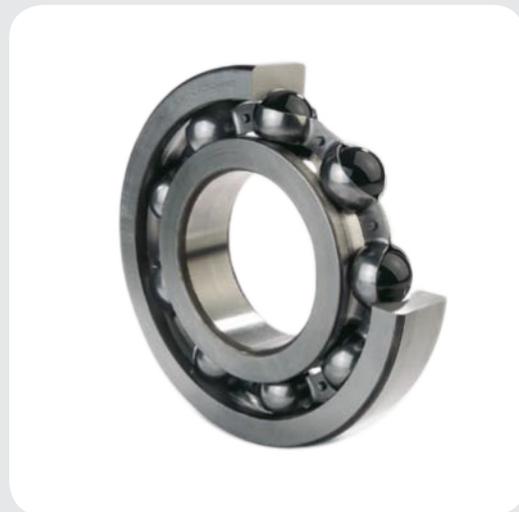
Figure 12: SKF Hybrid bearing

- In some applications with modern drives, insulated bearings may not always solve the problems. In these cases SKF Hybrid bearings are the preferred solution eradicating electrical erosion issues on motors. SKF Hybrid bearings have rolling elements in non-conductive materials like ceramics, the insulation between rotor and stator is perfect, avoiding all current types to circulate. See *figure 12*.
